To market, to market

This case study compares the different treatment methods of three historic tabletop wheat wagons (*pictured here*) that are very similar.

Case study treatment comparison

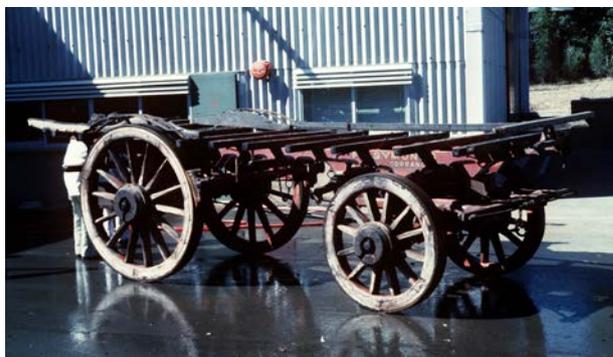
Case study 1. The 'Daylight' wagon prior to restoration. B1572

At the time of treatment in 1982, it was understood that the 'Daylight' was very significant and not many of these wagons were in existence. Restoration was common practice in museums throughout the world at that time. Due to the poor condition of the wagon, the decision was made to restore it. In retrospect, the course of action we would undertake today would be conservation treatment which would arrest the decay but would keep the historical integrity of the wagon.

The original colours of the 'Daylight' were very bold. When MAAS acquired the wagon in 1964, harsh weather conditions as well as dust, dirt and insects had taken their toll on it. In 1982, conservators examined the existing, faded paint of the wagon and identified the original colours. Paint manufacture has changed considerably since the wagon was made in 1909 and, whilst the colours may have been bold, they did not have the glossy shine of modern paints. However, the new paint used was made to match these colours at Museum's best practice standards. The wagon was completely restored by contractors who replicated the exact colours. The wagon was then coated with two coats of varnish. Unfortunately, no record of the treatment report was given to the Museum.

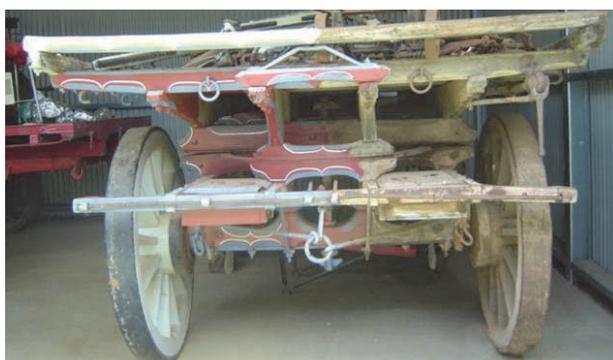
Case study 2. 'One of the Best' wagon on display at the Museum of the Riverina. Accession no 1052

One half of this wagon has been restored to the original colours of red with white, yellow, light and dark blue decoration. Two wheels have been painted light blue with dark, blue stripes. The other half of the wagon has been left in the condition in which it came to the museum.

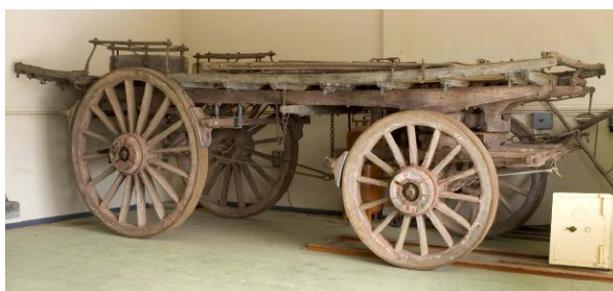
Case study 3. 'Australian Hero' wheat wagon owned by Dubbo Regional Museum 1996.

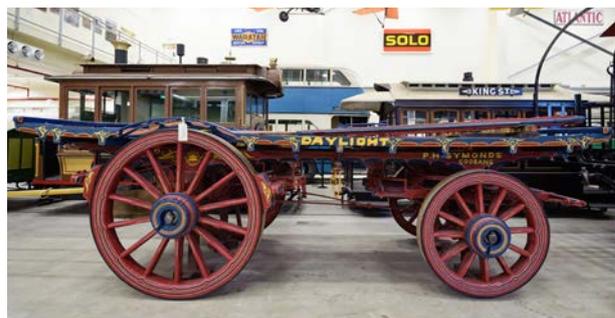
The restored 'Daylight' wheat wagon on display at the Powerhouse Discovery Centre.

no longer relevant as the object is stored in an environmentally stable building that is dust, pest and pollutant free and is displayed under low light. The original paint finishes have been irretrievably lost, as have the signs of wear that show the history of the wagon during its working life. This treatment would not be done today as it has destroyed the working history of the wagon.

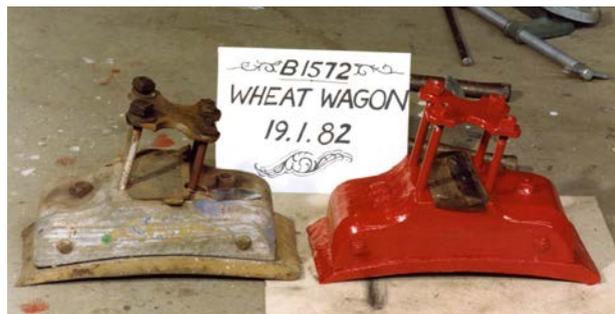
Brake pads showing the original condition and the restored condition.

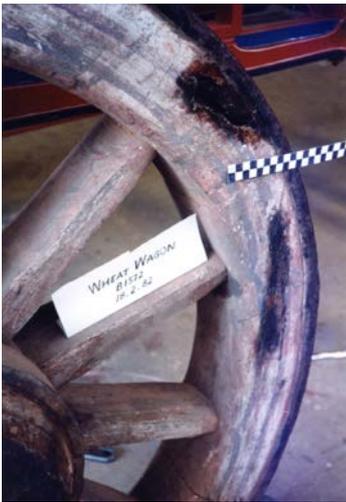
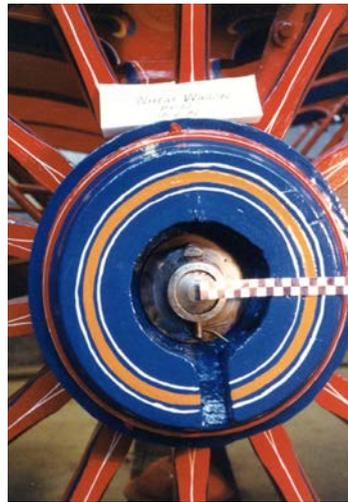
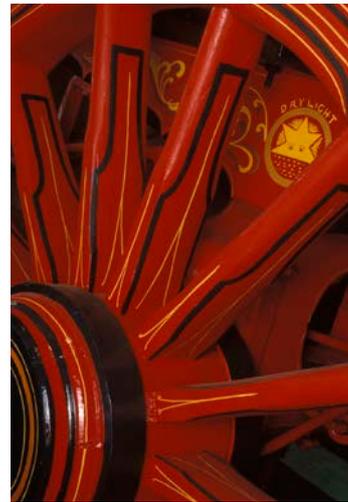
Original wheel showing damage, detail of restored wheel, and the rising sun label.

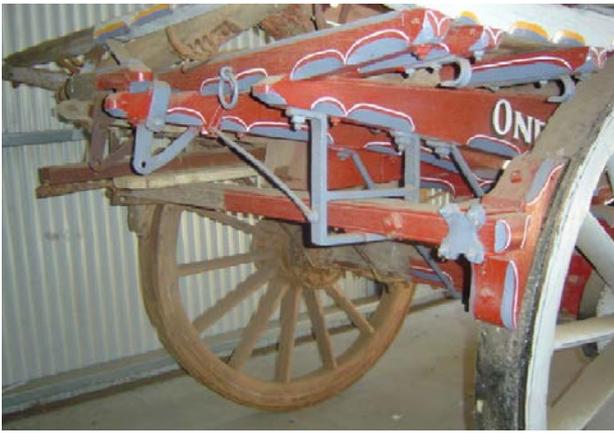
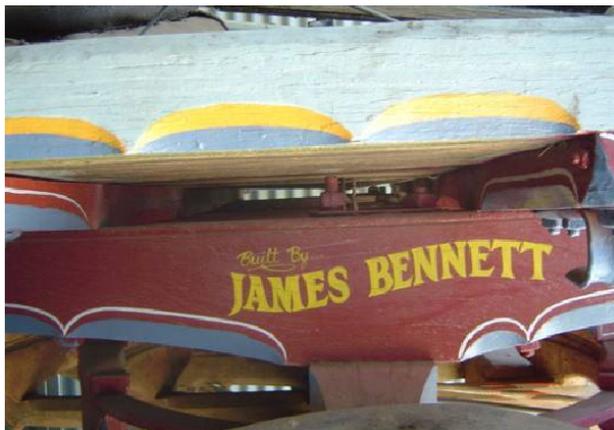
The restored half of 'One of the Best' wagon.

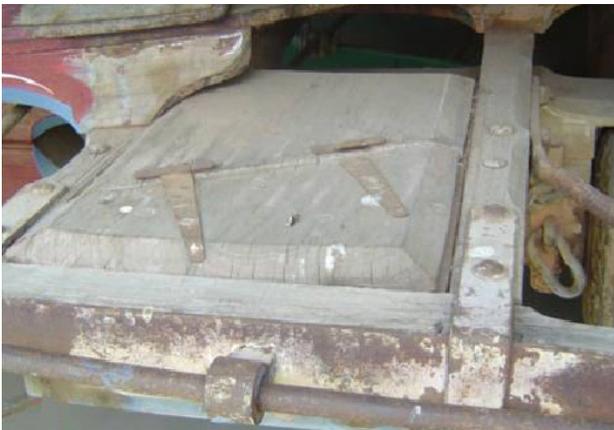
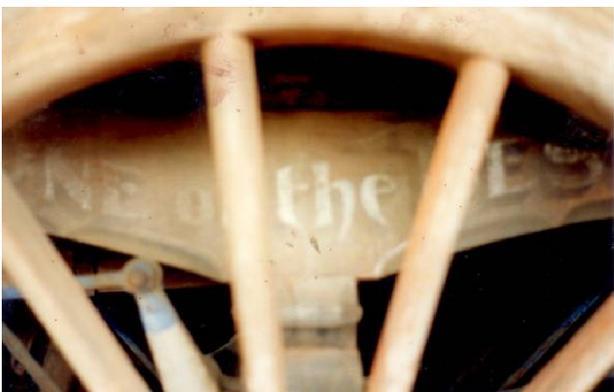
The unrestored half of the wagon showing the tool box and the original paintwork.

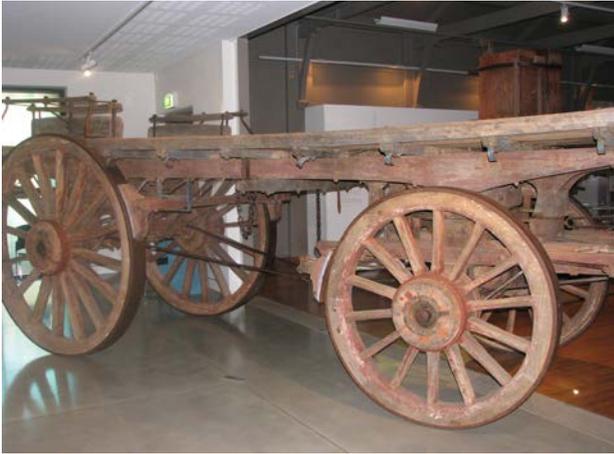
As you can see from the photo of the 'Australian Hero' wool wagon on display at the Dubbo Regional Museum, these caretakers have kept the historical integrity of the wagon by conserving and preserving it. The original paint finishes, signs of wear and tear, and repairs undertaken on it during its working life are still visible.

The 'Hero' wagon on display at the Dubbo Regional Museum.

This wagon has a far more interesting tale to tell than the other wheat wagons. It was conserved in 2009 when white rot was discovered, mostly in the planking section. This was treated and the wagon is now inspected on a quarterly basis. It is brush vacuumed every two years. The wagon is displayed in an environmentally-controlled building, with controlled lighting and is kept clean from dust, pests and pollutants. The 'Australian Hero' can tell its story for many generations to come. The museum staff understand and value its significance and they begin all their educational tours with the wagon. Damage such as the twisted rope hooks, faded colour and modified additions are pointed out to help describe its history. It is considered far more significant because it has not been restored.

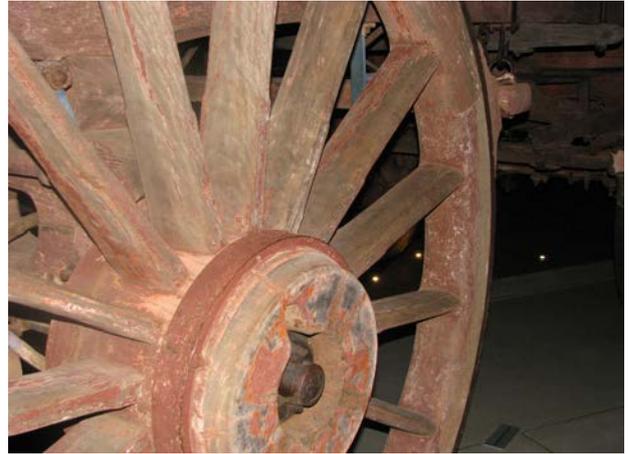
Original paint is still visible on the wheel of the 'Hero' wagon in Dubbo.
